Service Note:

E520/S500 Belt Pulley

Changing the E520 ABS/ S500Aluminum belt pulley

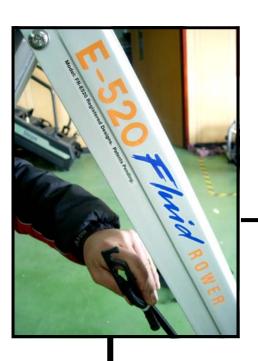
Step 1:
Stand the rower upright (use soft surface to avoid cosmetic damage to the pulley) and remove the bungee hook from rear of seat rail as shown.

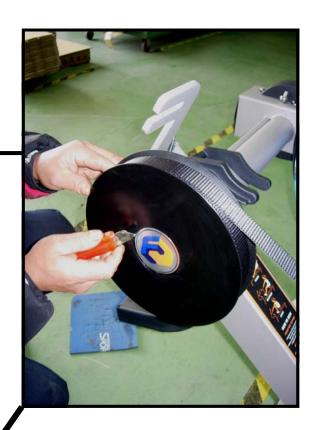
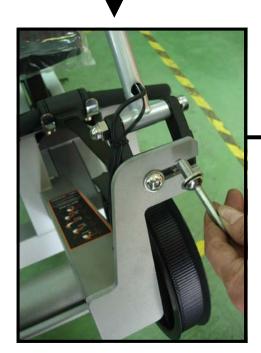
Step **3**, **4** and **5**:

With a box-cutter or other sharp implement, peel off the belt pulley sticker and discard (note that a new sticker is provided in the upgrade) Then, remove the C-clip (C-clip pliers are required) and spacer as shown below.

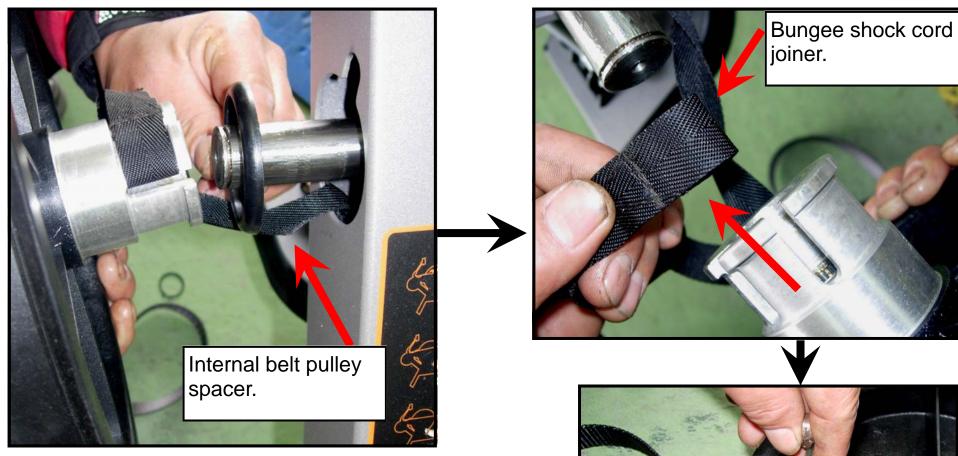
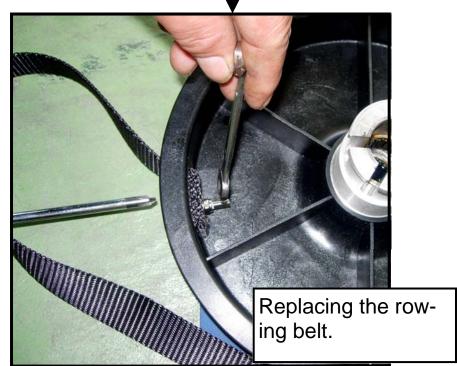
Step **6,7**, and **8**:

You may now remove the ABS pulley from the main shaft. Remove the "ear" end of the bungee shock cord from the pulley, and the internal belt pulley spacer behind it. Replace the bungee shock cord if required by removing through the bottom of the mainframe. Next, with a Phillips screwdriver and 8mm open wrench, remove the rower belt from the old pulley and mount onto the replacement as shown.

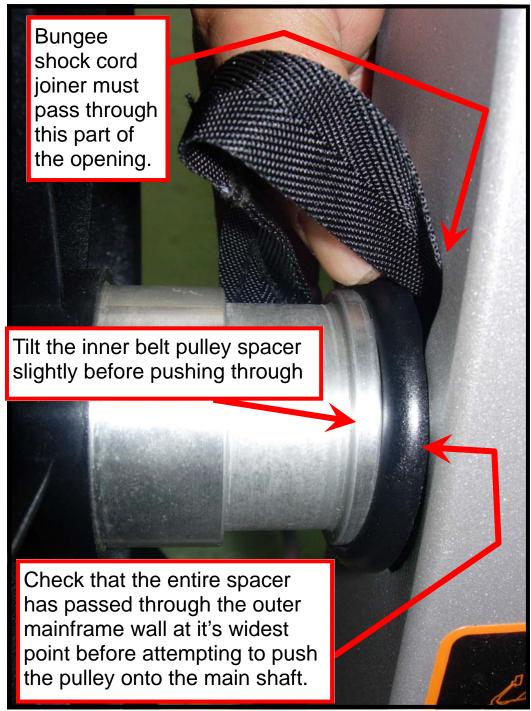
Step **9**: An entire page is dedicated to the remounting of the replacement pulley onto the main-shaft. The diameter difference between the internal pulley spacer and the outer-wall opening on the mainframe can be measured in tenths of a millimeter, and thus can present a real challenge when replacing.

First, remount the bungee shock cord onto the pulley and then direct the strap toward the upper opening on the outer-wall of the mainframe hole. Note that the bungee shock cord joining strap can easily get caught between the inner belt pulley and the mainframe, preventing the spacer from passing.

Tilting the spacer slightly just before pressing the pulley into the mainframe will help. Check all the way around the spacer to make sure the widest section has passed the outer wall of the mainframe, and then quickly with the other hand, firmly push the pulley into the frame.

Check that the pulley spacer has seated properly by pulling on the shock cord from the bottom of the mainframe. If it feels sticky, or not enough room is available to replace the spacer/C-clip on the outside of the pulley, the internal pulley spacer is most likely not seated properly. This may take a few tries. Once seated properly, finish the assembly by replacing the outer spacer, C-clip and belt pulley sticker, once normal operation has been established.
