Inspecting/Replacing the adjuster shaft O-rings for All models:

This service note applies to the following First Degree Fitness products:

Faulty adjuster shaft O-rings can allow water to seep along the adjuster shaft and out through the front of the tank. This service note covers inspection and possible replacement of faulty adjuster shaft O-rings.

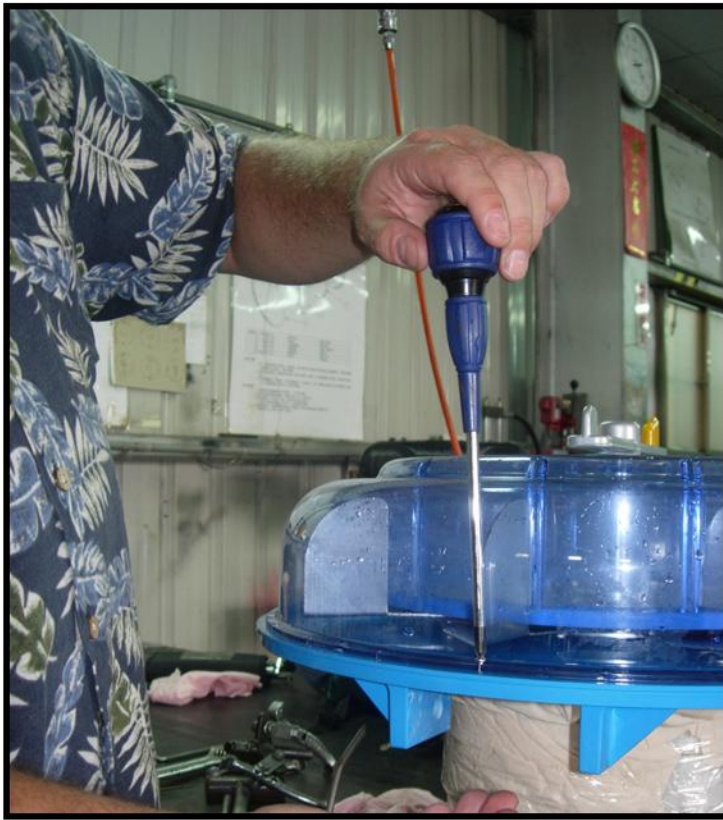
Step 1

Removing the PC tank cover

Start by removing Polycarbonate shell. Once the M3x12mm tank screws (12x) have been removed, use a rubber mallet and drop cloth and tap gently to break loose the outer tank seal. Remove the upper section of the tank, and inspect the O-ring for any signs of cracking tearing or binding. Replace if needed.

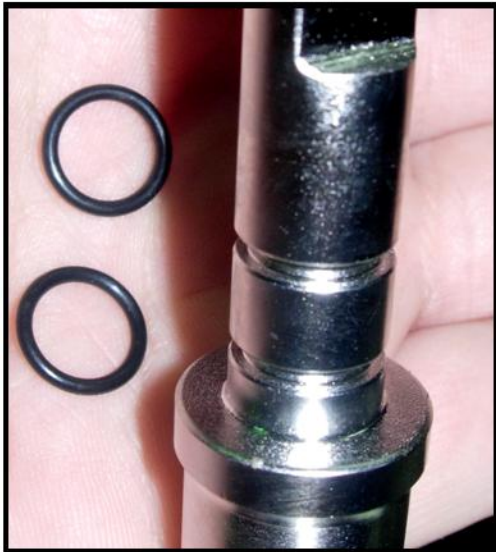
Next, remove the 2x small O-rings on the adjuster shaft for inspection. Due to their small size, a small crack or tear may go unnoticed. We recommend using a Magnifying glass for a more detailed inspection. If a fault in the O-rings is discovered, replace them. If the O-rings are undamaged, then lubricate lightly with silicone grease and reinstall them onto the adjuster shaft. Note that un-lubricated O-rings can easily slip out of position upon reassembly, a potential leaking point.

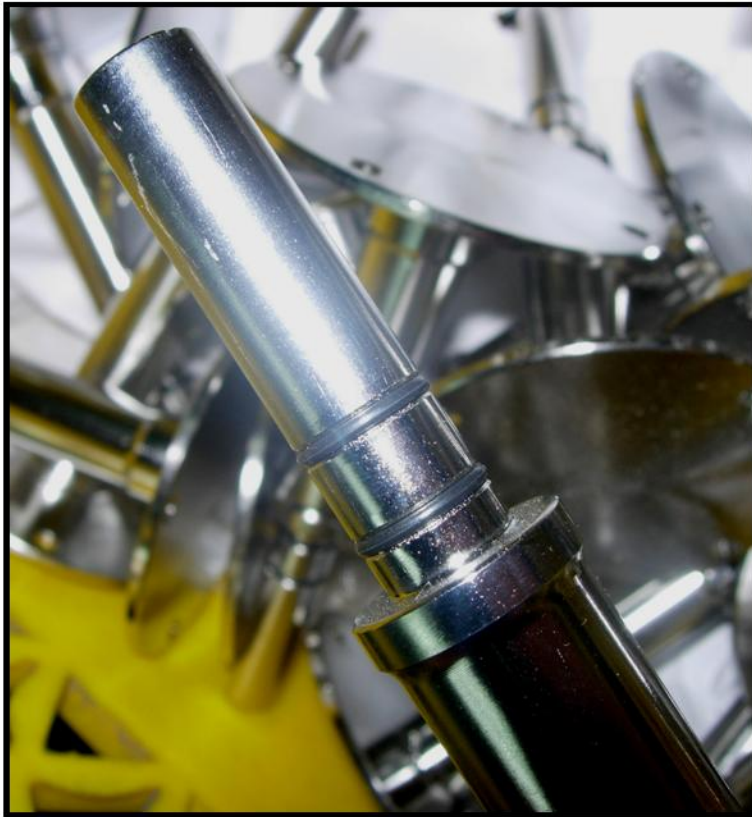
Reinstall the O-rings onto to the adjuster shaft. If you have removed the backing plate from the adjuster shaft then replace it now. Use a circular motion when pushing the O-rings and shaft through the Polycarbonate as shown. This helps the O-rings maintain their position in the adjuster shaft grooves...

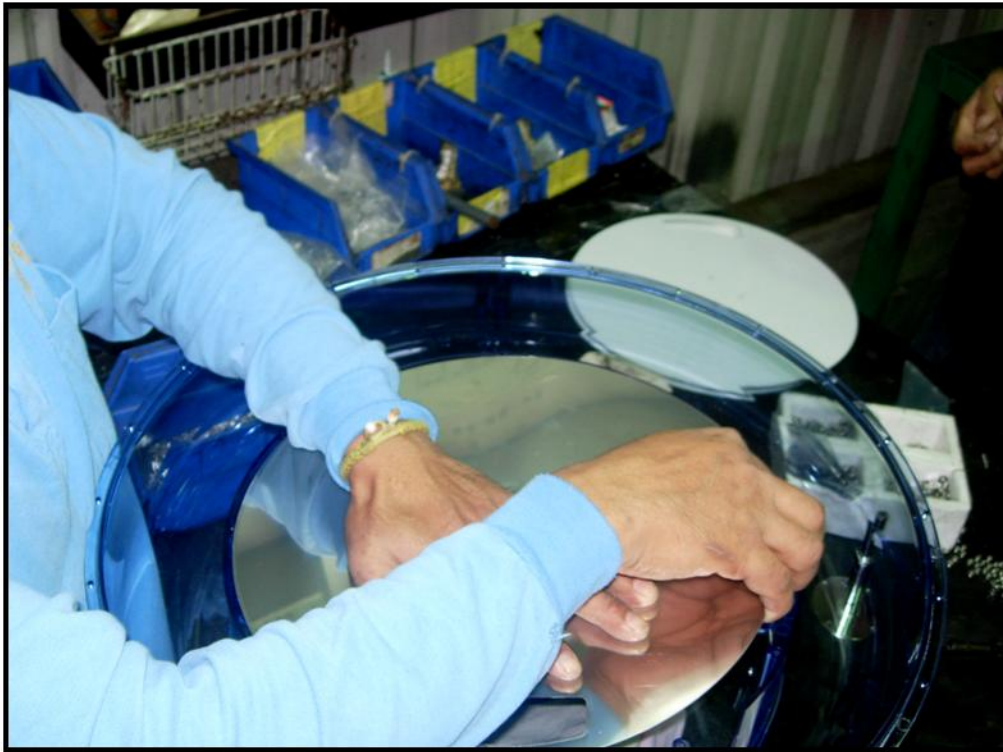
Before reinstalling the Polypropylene ring, it is advisable to “bend” the adjuster backing plate edge slightly. Place one hand in the middle of the backing plate and move use the other hand to pull upward, keeping the pressure on the middle hand to keep it even as you move your outer hand around the plate. This helps tension the plate onto the Polypropylene ring for better performance once reassembly is complete. Reinstall the Polypropylene screws as shown, using the same cross pattern as for a car tire.

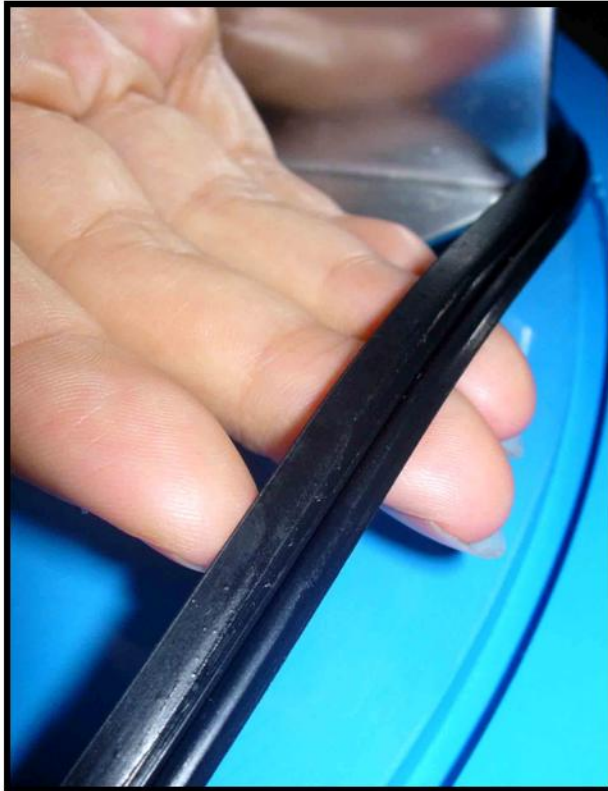
1. Lay the O-ring into the SMC O-ring groove, making sure it is flat and flush before securing the PC cover. An improperly laid and prepared O-ring will seep water over time. If the seal is excessively dry, then add a light coat of silicone.

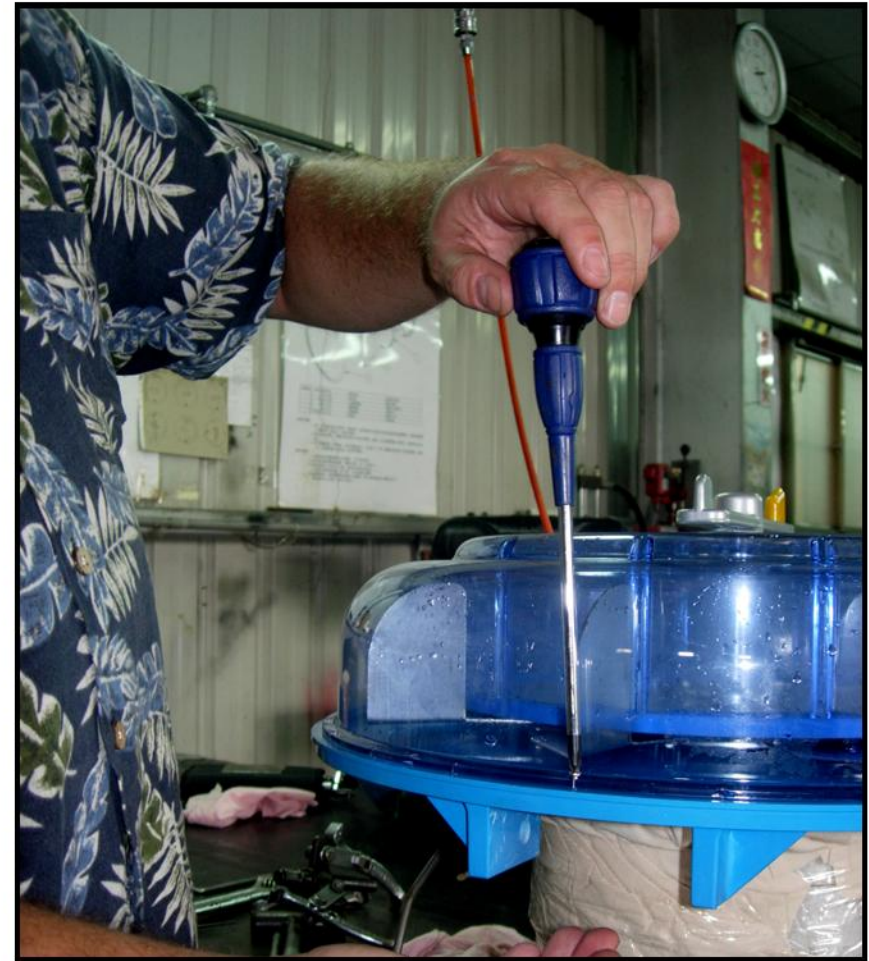
2. When attaching the PC cover, use a cross pattern with the screws. If a power tool is used, the lightest setting is more than enough to establish a seal. **Note over tightening the tank screws will readily crack the PC cover!**
